Single Axle Outside Rail Hoist

OR Series

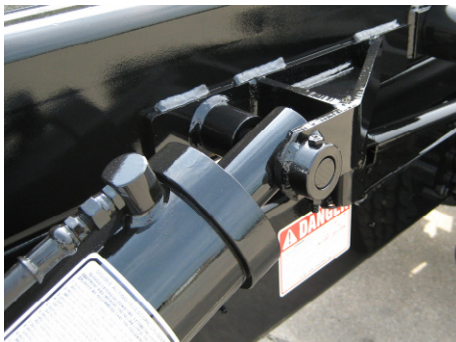
Outboard Supported Lift Brackets

Lift brackets increase stability when hoist is in the up position.

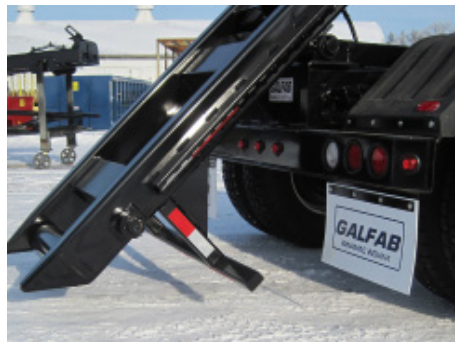
Rigid DOT/ICC Bumper

Durable bumper constructed from square tubing.

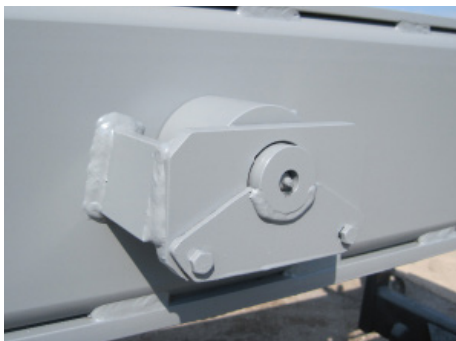
Outboard Supported Side Rollers

Greasable shaft is removable with two bolts.

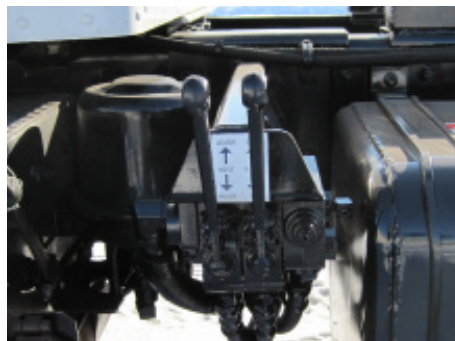
Outside Control Valve

Controls are easy access and makes maintenance very accessible.
